DEPARTMENT OF STATE HEALTH SERVICES

**Industrial Radiography Investigation
Findings and Trends
Chris Moore**

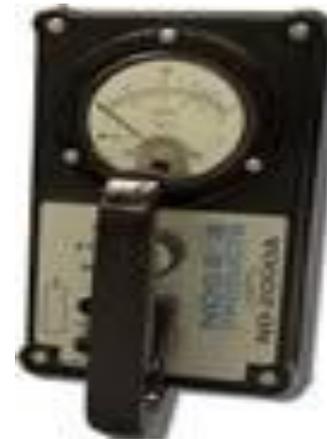
Radiography Incident #1

The radiographer failed to fully retract the source into the camera. The portable radiation meter was turned off and no radiation pagers alarmed. Both radiographers noted that their 0-200 millirem pocket dosimeters were off scale. They stopped work, fully retracted the source in the camera, and reported the incident to the RSO. The trainer had received 3.31 rem and the trainee had received 2.79 rem. The total exposure for the year for the trainer equaled 5.152 rem and he was removed from duty for 2011. The trainee had attempted to conduct a survey after cranking in the source but the meter was off for all three shots on the first weld and post use survey. Both radiographers stated they tested their electronic rate meters but the batteries appeared to be weak.

Survey Meter Off

- September 12, 2011
 - 67 curies Ir-192
 - 3.31 rem & 2.79 rem (dosimetry – badges)
- Administrative Penalty
 - Radiographer Trainer
 - \$1,000
 - Radiographer Trainee
 - \$0 (Trainee Status)
 - Company
 - \$1,625

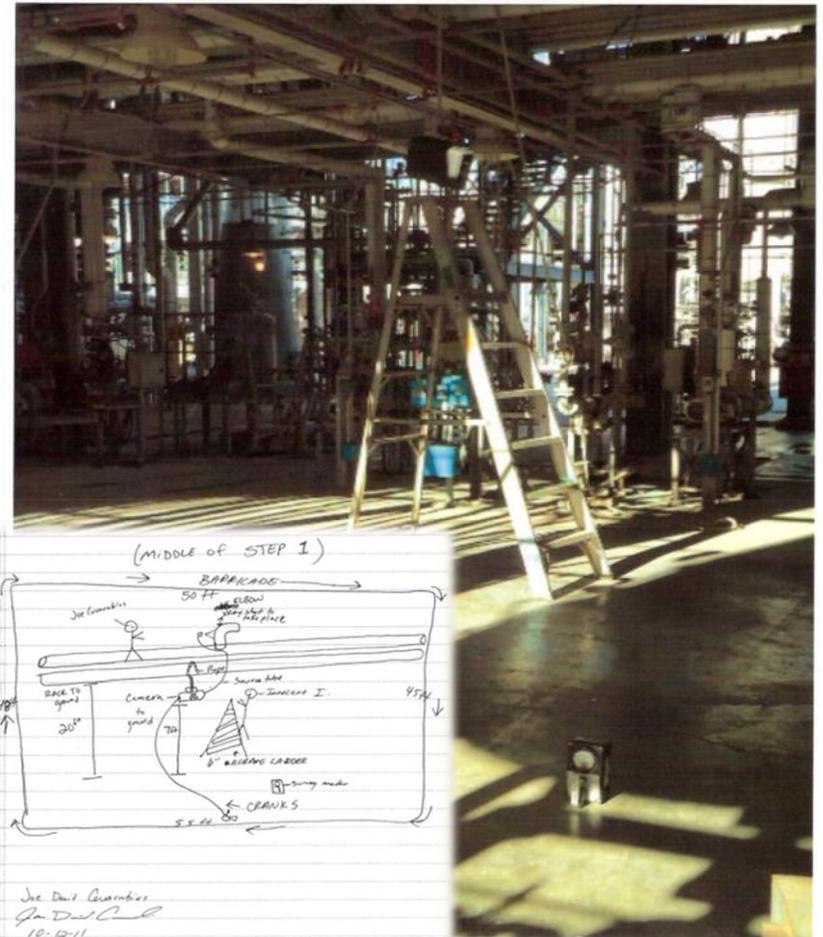
Radiography Incident #2

On October 17, 2011, the Agency was notified by a licensee that a radiographer had climbed a ladder to remove the guide tube from a QSA Model 880 radiography camera containing a 49.3 curie iridium-192 source that was suspended by a rope. As he was trying to disconnect the guide tube, another employee observed the radiographer's survey meter was indicating that the camera's source was not in the shielded position. The radiographer climbed down the ladder and cranked the source back into the camera. The radiographer's badge was sent for processing and the badge had a total effective dose equivalent reading of 4,192 mrem. The radiographer was unable to ascertain where the source had been in the guide tube. The whole body dose from the incident caused the radiographer to exceed the annual occupational dose limit of 5,000 mrem.

Camera on a Rope

- October 17, 2011
 - 49.3 curies Ir-192
 - Badge processed:
 - 4,192 mrem TEDE
 - 58.15 rem to hand (estimated)
- Administrative Penalty
 - Radiographer
 - \$1,000
 - Company
 - \$3,250
 - + \$2,000 probated 1 yr

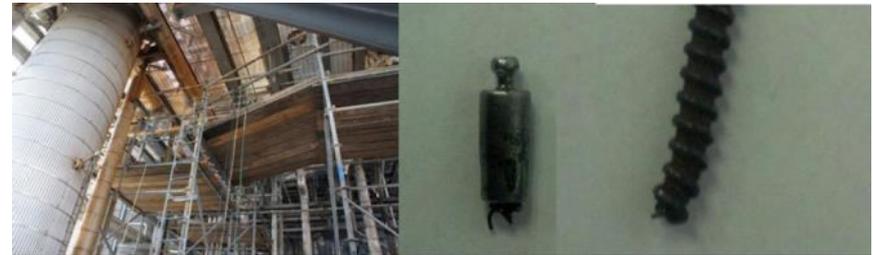
Radiography Incident #4

A radiography team had experienced a disconnect of a 65 curie iridium-192 source on a QSA Delta 880 radiography camera at a temporary work site in Pasadena, Texas. The crank out drive cable had broken at the pigtail and the source had disconnected. After an authorized individual performed the source retrieval, the licensee's RSO learned that the radiographer trainer disconnected the source guide tube from the camera and had carried the source guide tube around his neck while he climbed down the ladder of the scaffold. The source was still in the source guide tube at this time. When the radiographer trainer reached the platform he removed the source tube from his neck and laid it on the platform. The licensee and the Agency conducted an investigation into the event. The licensee performed dose assessment calculations and estimated the radiographer received 29.32 rem (whole body, deep dose equivalent) during this event.

Guide Tube Necklace

- March 24, 2012
 - 65 curies Ir-192
 - 29.32 rem (estimated)

Male Coupling

Drive Cable

- Administrative Penalty
 - Radiographer
 - \$600
 - 12 Mo. Suspension
 - Company
 - \$2,500

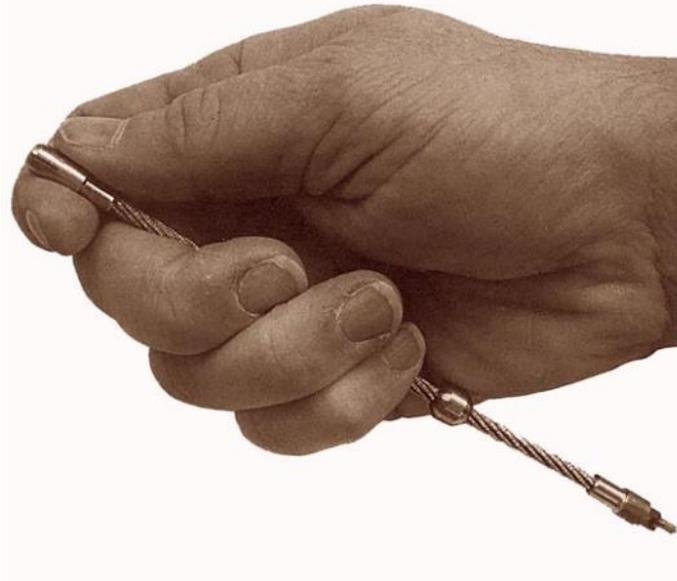
The Agency contacted the RTT in the hospital. The RTT stated that he was performing radiography using a camera containing 73 curies of iridium - 192. He stated that the last shot had been completed and he was removing the guide tube to move the camera. He stated that when he removed the guide tube, he saw the source sticking out of the front of the camera about 2 inches. He stated that he immediately retracted the source to its fully retracted and locked position. Three days later, his right thumb, index finger, and middle finger began to swell and turn yellow. At this point he began to seek medical attention ending up in the hospital in Houston, Texas.

Estimate that his hand was near the source for 10 seconds

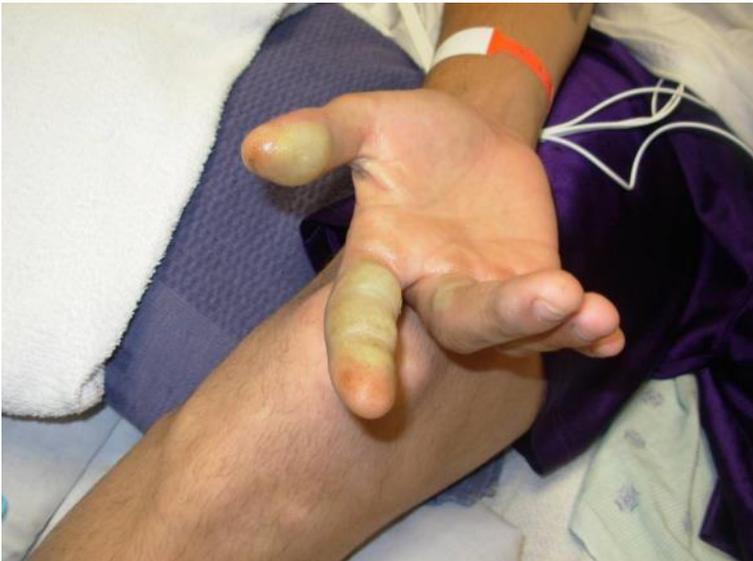
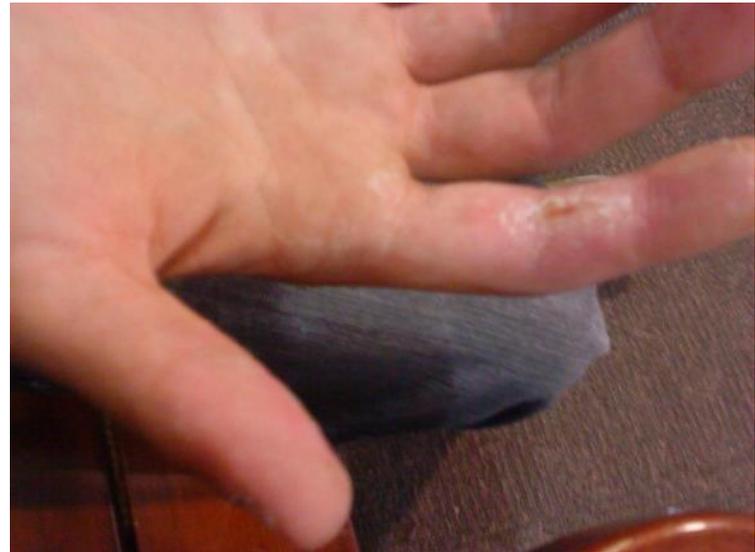
Several days to weeks Later Sep 2011

-Night of incident swelling started and blisters formed in three days

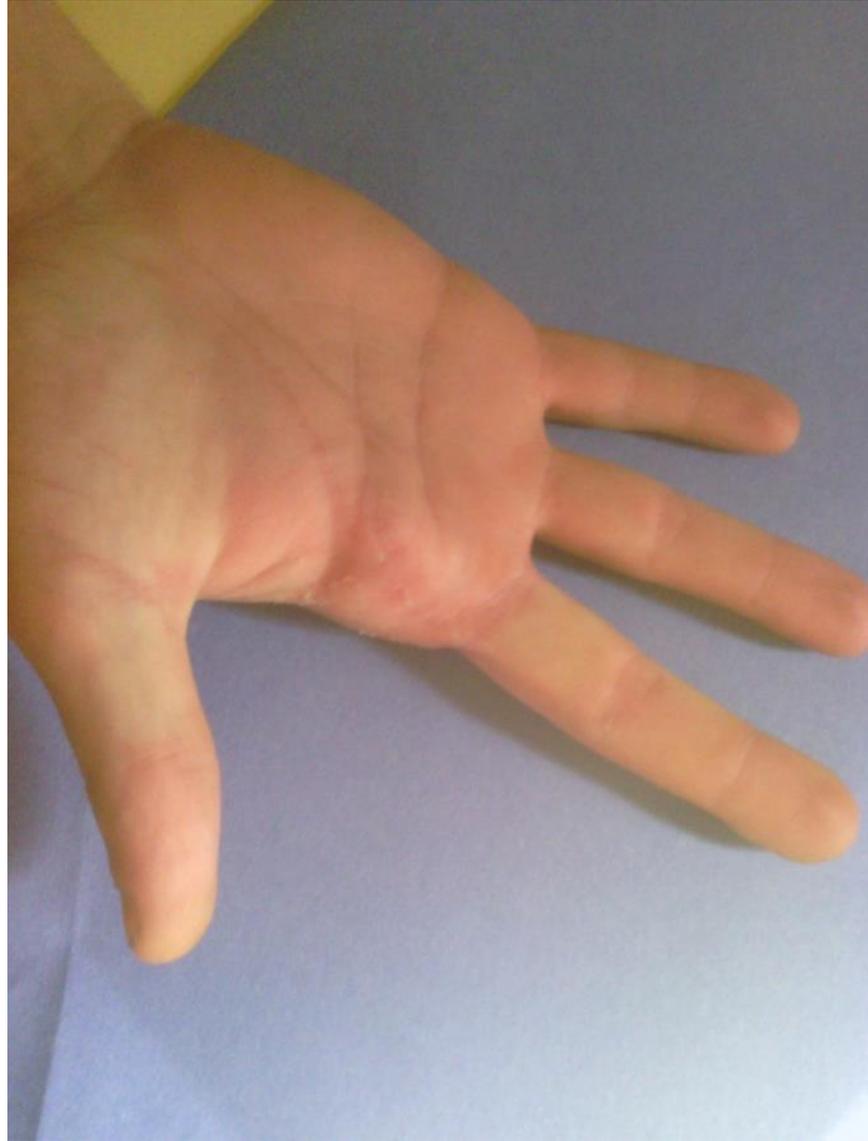
Early 2013

- 73 curies Ir-192
- 2703 rem to the fingers
(estimated)
- Administrative Penalty
 - Radiographer
 - Licensed Revoked
 - notified additional states
 - Company
 - \$16,500
